## NASA Contractor Report 3418

# Service Evaluation of Aluminum-Brazed Titanium (ABTi)

S. D. Elrod
Boeing Commercial Airplane Company
Seattle, Washington

Prepared for Langley Research Center under Contract NAS1-13681

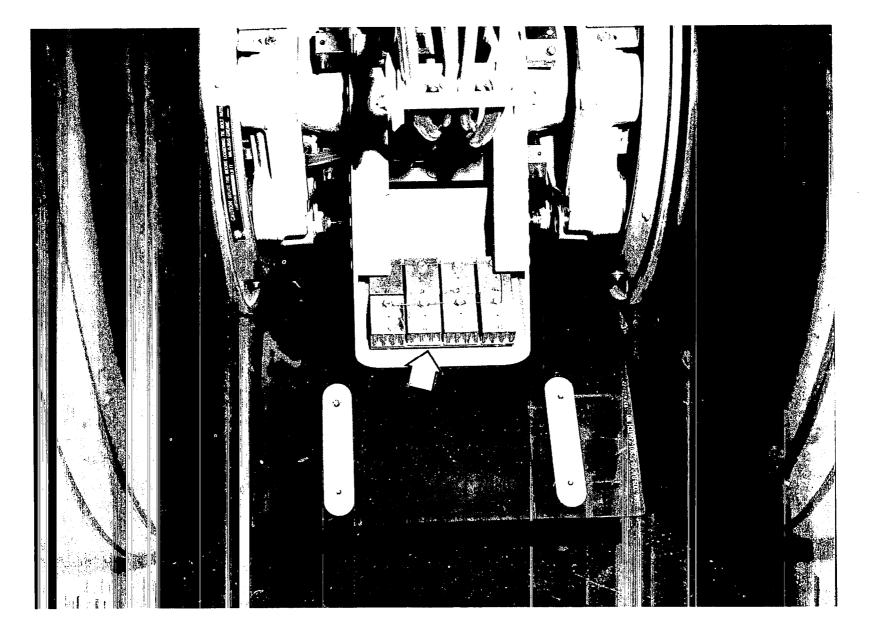
Figure 5.— Corrosion Flight Test Kit Mounted on Model 727 Main Landing Gear

The flight test specimens were enclosed in the unheated, unpressurized wheel well during flight and were partially sheltered by the wing when the airplane was on the ground. During takeoff and landing, the specimens were exposed to rain, spray, slush, runway deicing materials, reverted rubber deposits, engine exhaust fumes, and the local corrosive atmospheric contaminants. The specimens were mounted on 18 aircraft flown under routine conditions by nine commercial airlines (Air France, All Nippon, Braniff, Continental, Libyan Arab, Lufthansa, Northwest, Trans World, and Western). Flights were operated in Europe, Japan, the Middle East, North Africa, and the United States, exposing sets of specimens ranging from temperate-inland to tropical-marine (mild to highly corrosive).

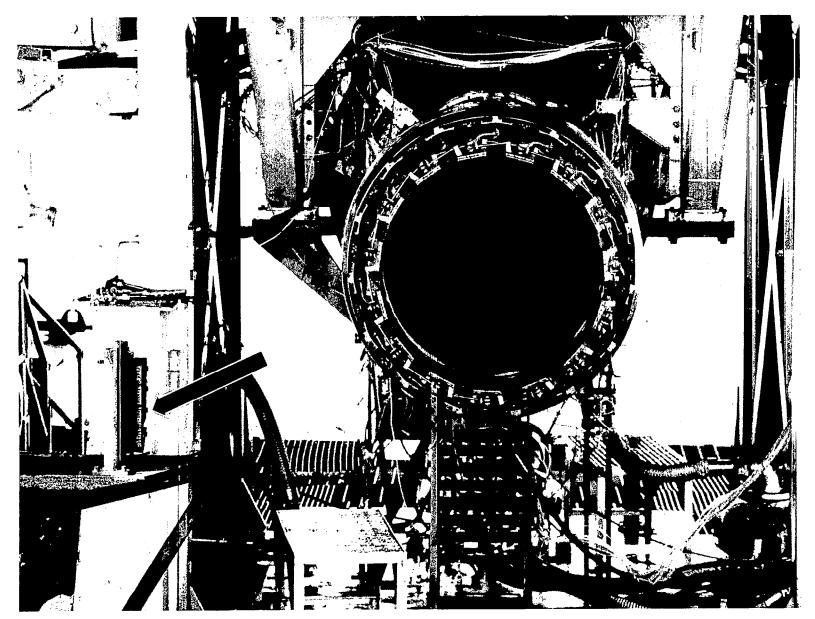
Figure 6.— Corrosion Specimen Kit Mounted in a Jet Engine Exhaust Zone (Pratt & Whitney — Florida)

Specimens also were tested in the Pratt & Whitney Florida Research and Developmental Center (FRDC) (West Palm Beach, Florida) facility in an outdoor test stand, completely exposed to the Florida weather. The facility is approximately 32 km (20 mi) inland from the east Florida coast and subject to prevailing force 4 winds from the ocean. During engine operation, the FRDC specimens were subjected to the exhaust blast at a location 5 m (16.5 ft) to the rear and 1 m (3.5 ft) left of engine centerline, as shown in figure 6. The FRDC specimen temperature ranged from 85°C (185°F) during unaugmented operation (approximately 38 percent of the

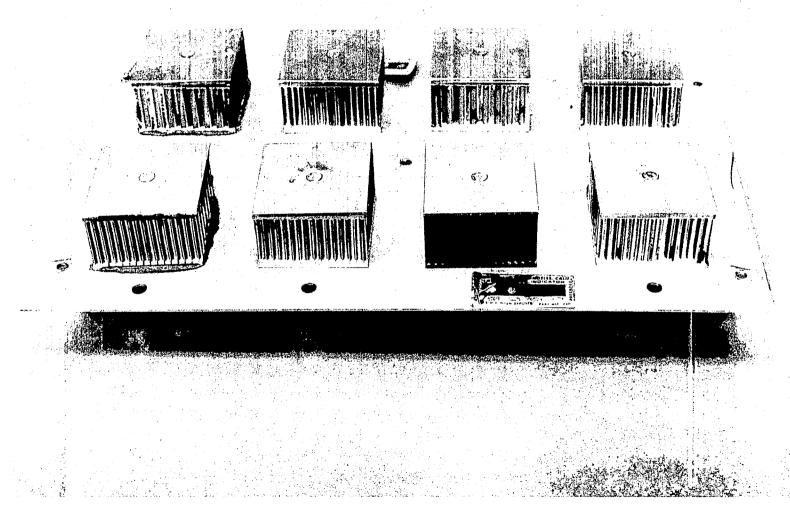
Figure 7.— Supersonic YF-12A Test Specimens

The flight test specimens were mounted in an unpressurized dry wing bay and were sheltered from direct contact with the weather. The specimens were subjected to low temperatures and periodic moisture condensation during subsonic flights and to 200° to 260°C (400° to 500°F) temperatures at very low atmospheric pressures during Mach 3+ supersonic flights.

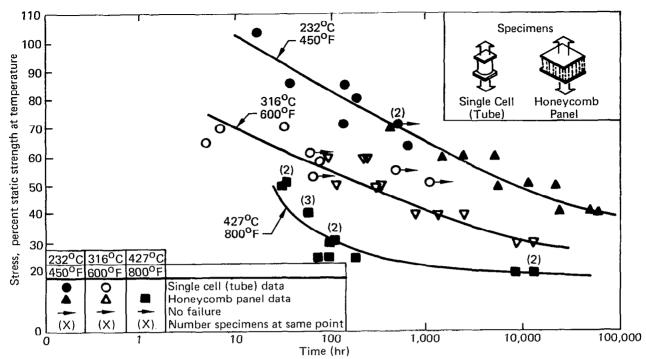
Figure 9.— Summary of Creep-Rupture Data

The results of the honeycomb sandwich stress-rupture tests are shown in figure 9. This figure contains data generated on the SST and DOT follow-on programs as well as the current contract. Failure in all cases occurred in the braze but was attributed to prior creep of the core that relaxed the triaxial stresses at the root of the braze.

The data show that the flatwise tensile strength of ABTi sandwich is time dependent, with a leveling phenomenon analogous to a fatigue endurance limit. This limit is approximately 40 percent of the static strength sustained load,  $4.1 \times 10^6$  Pa (600 psi) at  $230^{\circ}$ C ( $450^{\circ}$ F). At  $316^{\circ}$  and  $425^{\circ}$ C ( $600^{\circ}$  and  $800^{\circ}$ F), the limits are approximately 30 percent and 20 percent sustained load,  $2.8 \times 10^6$  and  $1.4 \times 10^6$  Pa (400 and 200 psi), respectively.

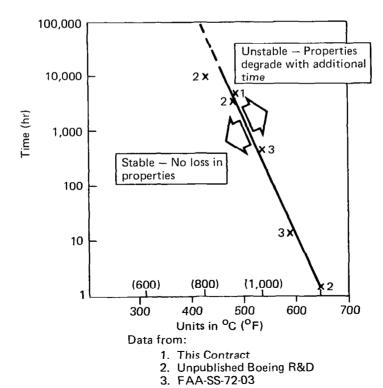
Figure 10.- Metallurgical Stability of ABTi

Specimens from this contract, prior DOT programs (FAA-SS-72-03, ref. 3), and unpublished Boeing R&D programs were sectioned after thermal exposure and the thicknesses of the titanium aluminide (TiAl<sub>3</sub>) interface layers were measured for growth during the thermal exposure. If no significant growth of the aluminide layer occurred, the braze was considered metallurgically stable at that exposure. Figure 10 is a plot of combined data showing the time/temperature limits. These data reveal that the braze joint has long term metallurgical stability at temperatures up to  $425^{\circ}$ C ( $800^{\circ}$ F) and is usable at higher temperatures for shorter times.

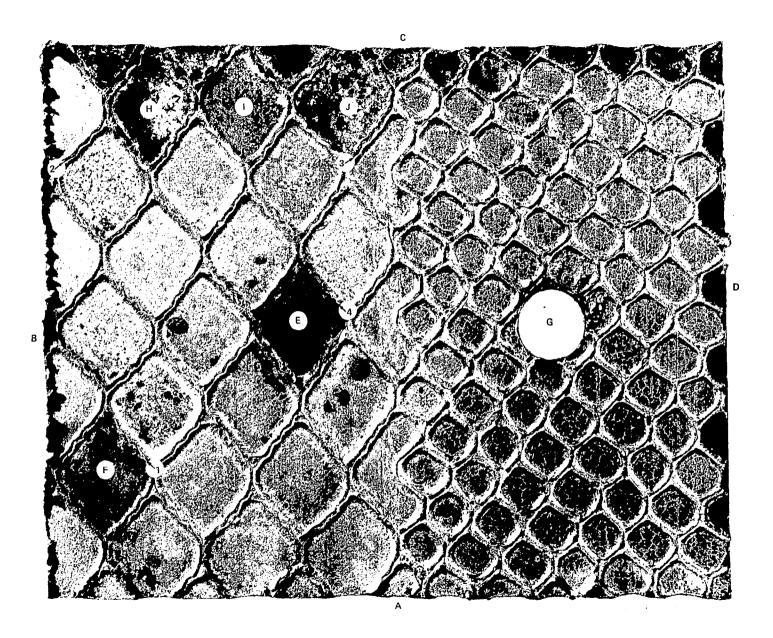
Figure 11.— Face Skin From 727 Landing Gear Structural Specimen

The corrosion morphology on a specimen from the 727 airplane landing gear test is representative, in kind, of all types of specimens and aircraft applications. Figure 11 illustrates salient features. This photo shows the entire 3.8- by 5.1-cm (1.5- by 2.0-in.) face skin removed from a 727 landing gear test specimen. Sides marked A and B were painted with a corrosion protective primer; sides C and D were left bare. G is the attachment hole and E is the cell with a vent hole in one skin. Neither E nor G (on this specimen) received any protective finish (see fig. 1). This particular specimen had been on the airplane for approximately 5 years.

Cells marked H, I, and J had open nodes at the outside edge. Cell F had a small slit at the bottom of a cell wall (see fig. 12). This slit permitted some moisture to enter but also provided a drain such that water could not accumulate. Cell E contained the vent hole in the upper skin that would permit moisture to enter and accumulate without draining. The fastener hole G was not sealed (slip-fit fastener), but was shielded from liquid water by the fastener head. (The deposits around the hole are residual adhesive from bonding loading blocks for the flatwise tensile test.) The fillets marked 1 through 4 are the locations of scanning electron photomicrographs (SEM) discussed later. The various areas illustrate the corrosive behavior of ABTi.

Cell E, with an exposed vent hole, which can accumulate liquid water, represents the worst condition. (Acoustic sandwich that has more and/or larger holes is worse than this specimen because water can enter more readily, but the difference is in amount, not kind.) The entrapped water dries more slowly than an exposed surface, which increases the time the aluminum is wet and, hence, the amount of corrosion. The SEM photograph of fillet 4, figure 16, shows that the exposed side of the fillet is almost completely gone and corrosion has penetrated beyond the cell wall to the inner side of the fillet.

An area such as the fastener hole, G, that is accessible to water vapor but not to liquid water, does not corrode.

The small degradation in the structural specimens revealed by statistical analysis would not occur if (1) all of the edges had been painted and (2) there had been no vent hole. If a crack should develop in service, it would be expected to act similar to the fastener hole (with regard to corrosion), as there would not be sufficient opening to permit ingress of liquid water.

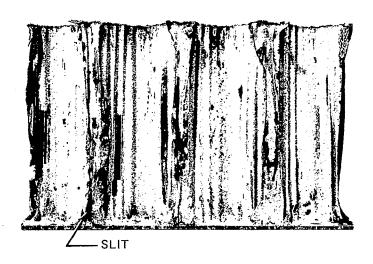
Figure 12.- Side View of Specimen Showing Slit In Wall of Cell F

Cell F experienced a minimum exposure to moisture because of the small opening into the cell. The resulting corrosion within the cell was also minimal. The SEM photo of fillet 1, figure 14, shows the initiation of corrosion pits and the start of intergranular attack.

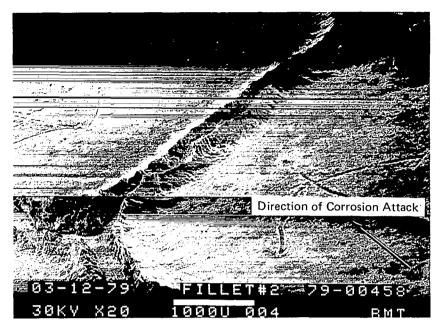
Figure 13.—SEM Photograph of Fillet Number 2 Showing No Evidence of Corrosion Attack

Sides A and B, which were coated with a chromate-inhibited epoxy primer, are representative of any exposed aluminum that has been given an appropriate protective finish. The SEM photograph at cell wall 2, figure 13, shows the surface of the fillet to be smooth with no evidence of corrosive attack. The results confirm prior testing (ref. 1) that an appropriate protective finish prevents corrosion.

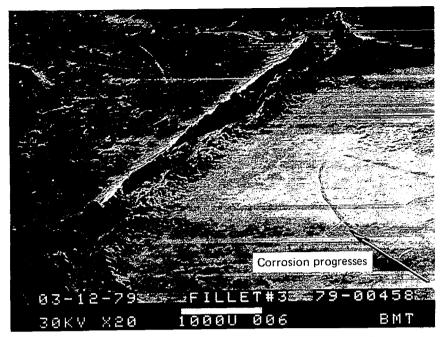
Figure 15.— SEM Photograph of Fillet Number 3

Call J was completely open to moisture. The SEM photo of fillet 3, figure 15, shows that corrosion has progressed along grain boundaries over the entire fillet surface; however, after 5 years, the basic structure of the fillet is still intact and able to sustain load.
